Ajka Alumina Plant Red Mud Dam Failure

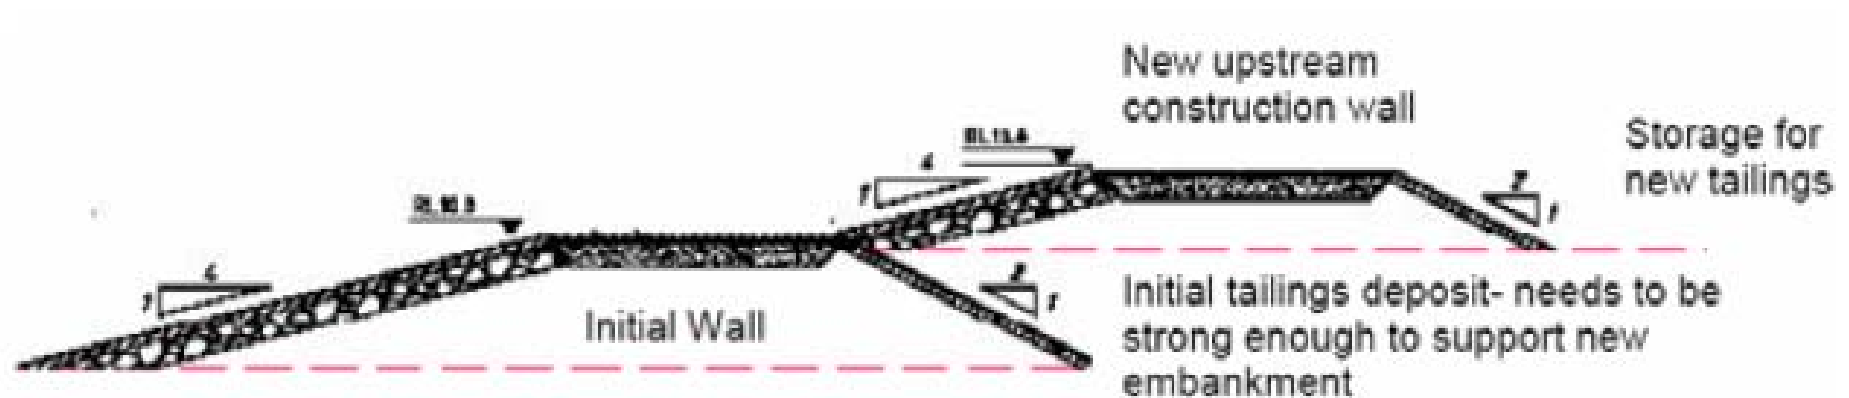
Figure 3. The Upstream Construction Technique

- Wall raised incrementally
- Mud inside dam conditioned to provide foundation support
