Ajka Alumina Plant Red Mud Dam Failure

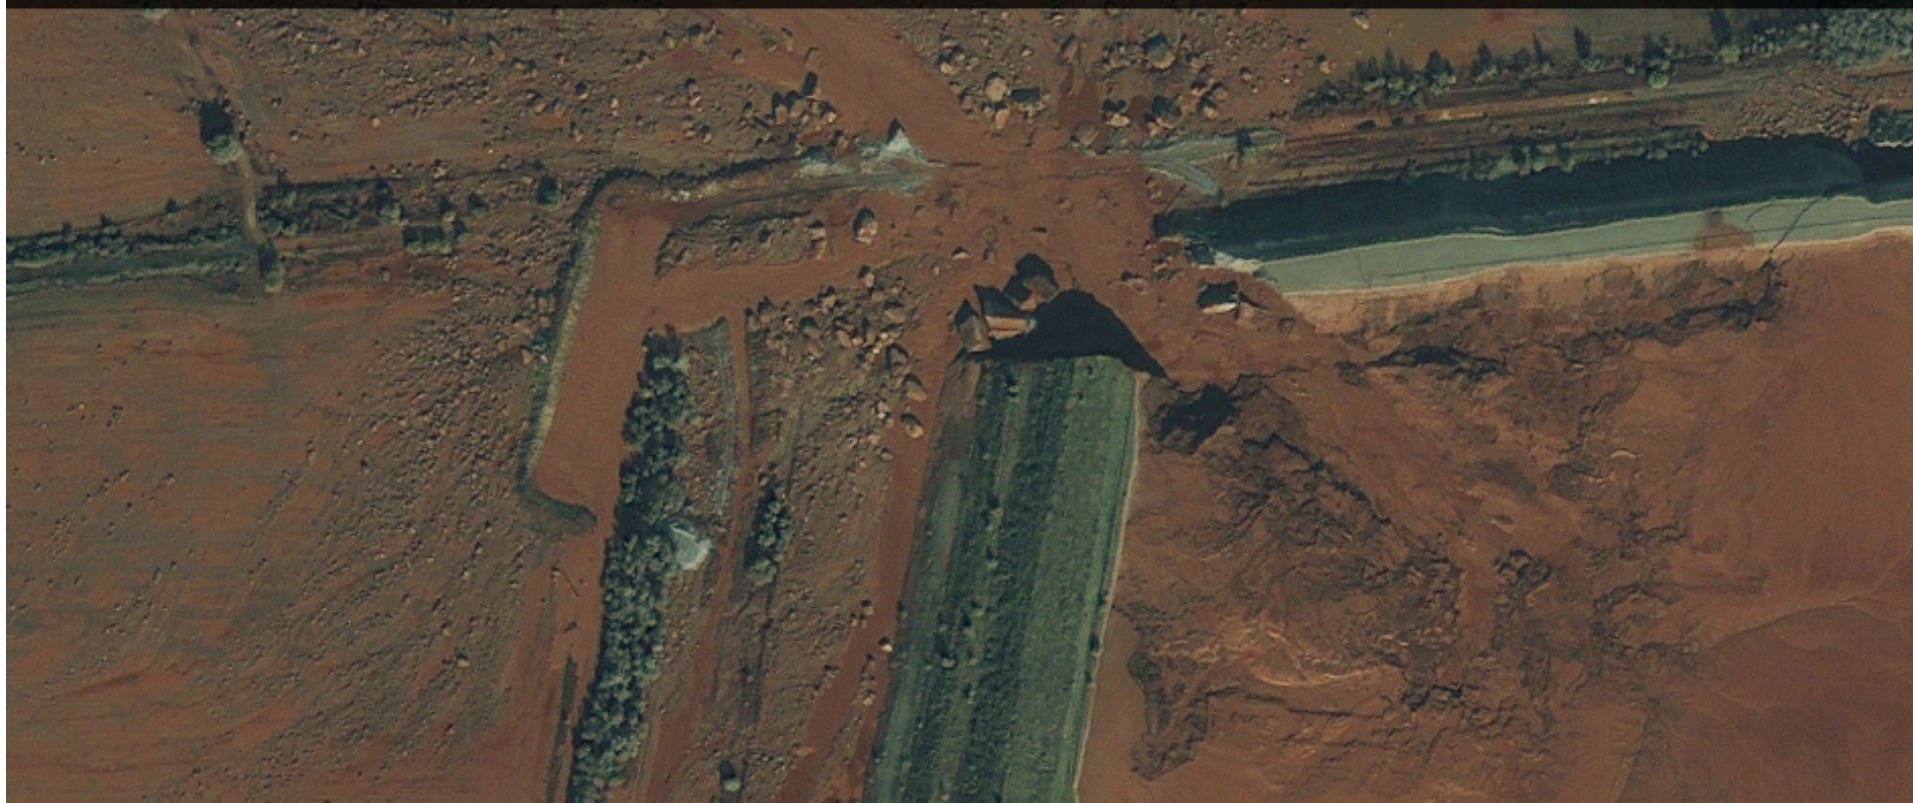
This one-meter resolution satellite image features a portion of Hungary's toxic sludge spill east of Kolontar, Hungary. The image was taken on Oct 7, 2010 and shows a close-up of the holding pond where the red mud pollution broke through wall. On the same day the image was captured authorities reported the spill had reached the Danube River, threatening to contaminate the waterway's ecosystem. The image was collected by the IKONOS satellite from 423 miles in space as it moved from north to south over Hungary at a speed of four miles per second.
